**AWE Fire Investigation**  
**Key Findings and Company Responses**  
**document**  
**For AWE Local Liaison Committee**

On the evening of Tuesday 3 August 2010, a solvent fire broke out in an explosives production building on the Explosives Licensed Site at AWE Aldermaston.

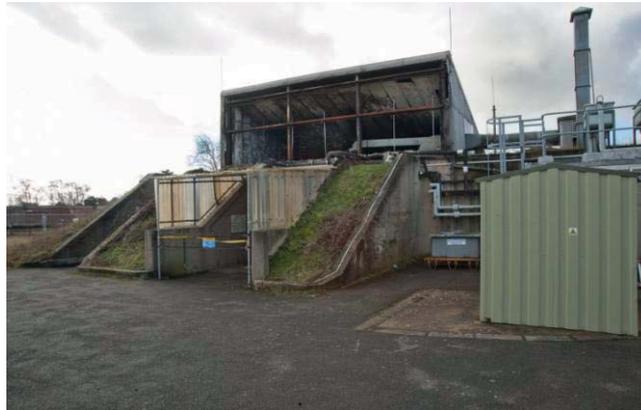
External view of the building after the fire

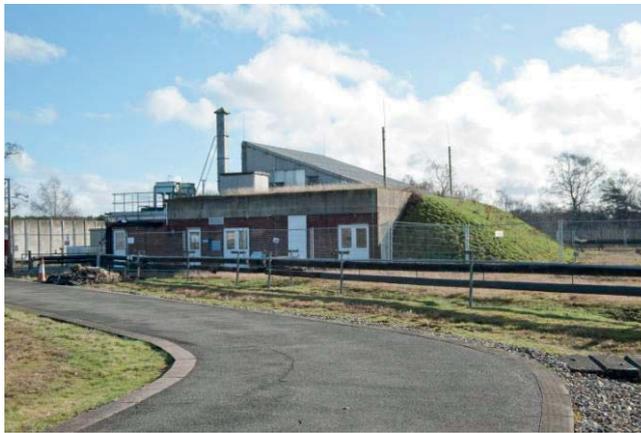
External view of the building after the fire

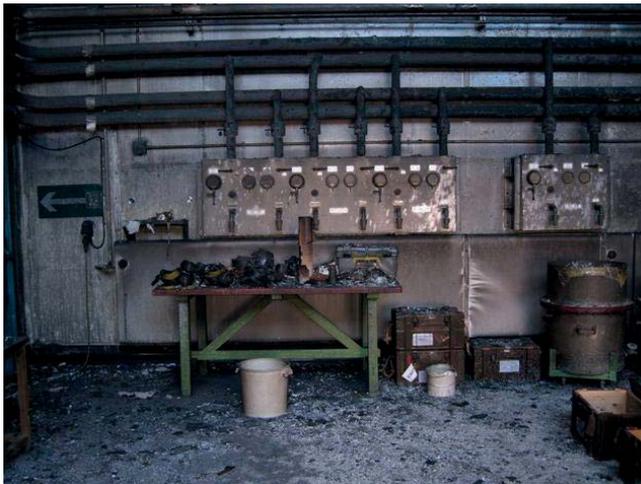
Internal view of the building after the fire

Following assessment, the fire was allowed to burn out during the night. This minimised any risk to emergency response crews and is normal practice in such circumstances. Damage was limited to equipment and materials inside the building with only minor impact on the building fabric. The fire did not spread to any adjacent areas and was confirmed to be out by 2am.
